# RESEARCH, DEVELOPMENT and TECHNOLOGY TRANSFER QUARTERLY PROGRESS REPORT (QPR)

Wisconsin Department of Transportation (WisDOT)  
DT1241 5/2014

The current WisDOT Bridge Manual recommends using “pervious” granular backfill behind bridge abutments to prevent lateral water pressures on the abutment walls. The granular backfill material is considered “pervious” or “free-draining” based on its grain-size distribution properties. However, the “free-draining” assumption of granular backfill does not properly consider:

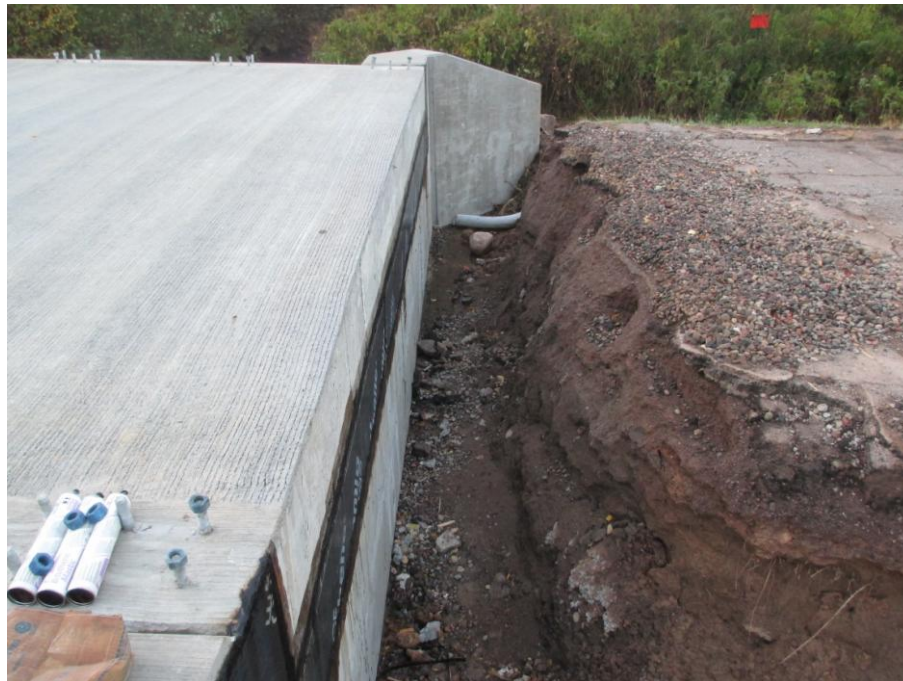
**Figure 1. Hobbles Creek Bridge Abutment in Price County, WI**

Field testing and instrumentation was conducted on the final two bridge locations at Hobbles Creek Bridge in Price County, WI (Project #3) on October 6, 2014 (Figure 1) and Badger Road Bridge in Grant County, WI (Figure 2). ISU research team conducted dynamic cone penetrometer (DCP) tests at the bottom of the excavation and at the top of the backfill after all lifts were placed for both sites. Results for Hobbles Creek Bridge and Badger Road Bridge are shown in Figure 3 and Figure 4. DCP results indicate increasing CBR with depth due to confinement. Air permeability tests (APTs) and corehole permeameters were conducted at both sites. The air permeability tests for Hobbles Creek Bridge indicated a saturated hydraulic conductivity of 0.3 cm/s (822 ft./day). Corehole permeameters for Hobbles Creek Bridge were performed at 3 times with water continuously flowing to identify the change in hydraulic conductivity as saturation increased. These values can be seen in Figure 5. The initial hydraulic conductivity found to be 0.006 cm/s (16.4 ft./day) at the start of the test and after saturating for 83 minutes was found to be 0.005 cm/s (13.3 ft./day).

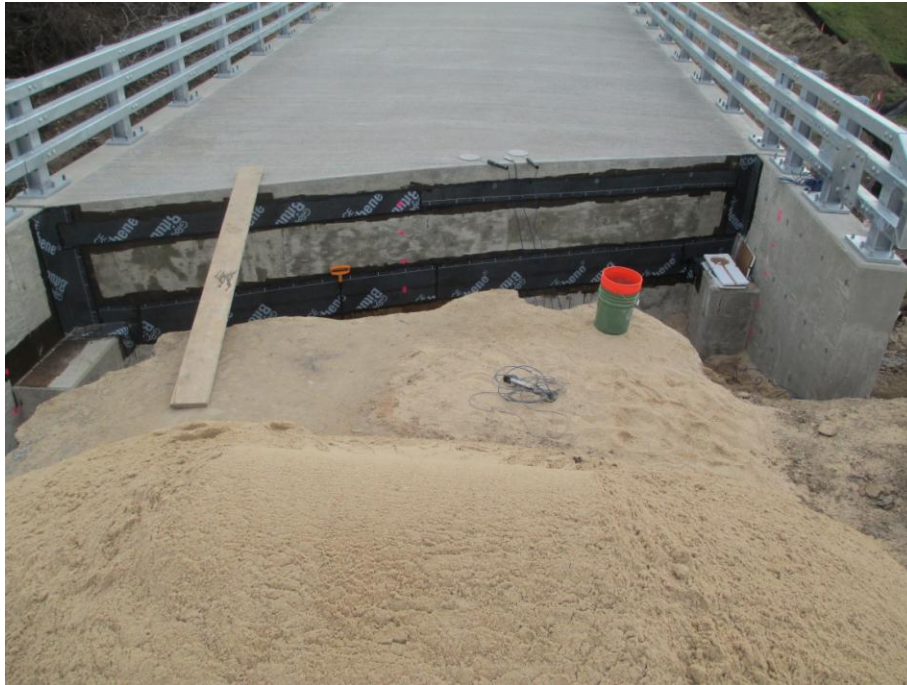
**Figure 2. Badger Road Bridge, Grant County, WI**

APTs at Badger Road Bridge indicated a saturated hydraulic conductivity of 0.70 cm/s (1984.3 ft./day). Corehole permeameter tests indicated a saturated hydraulic conductivity of 0.06 cm/s (127.9 ft./day)
